Mars Climate Orbiter

Mishap Investigation Board

Phase I Report

November 10, 1999

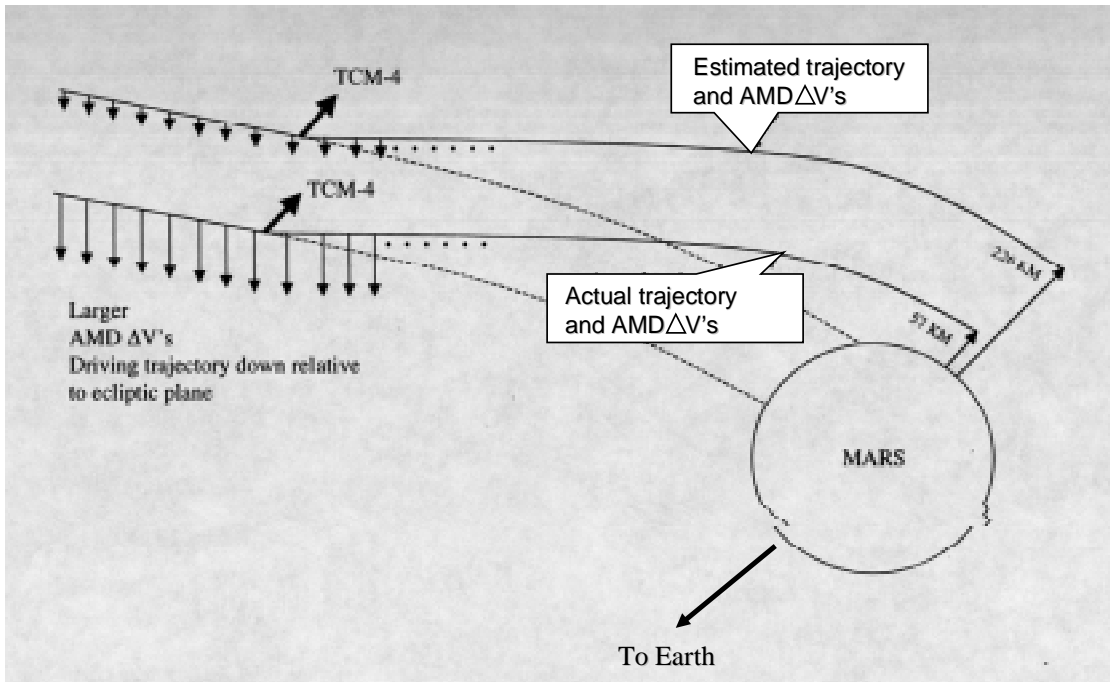
Figure 4

The MCO had been on a trajectory toward Mars since its launch on December 11, 1998. All spacecraft systems had been performing nominally until an abrupt loss of mission shortly after the start of the Mars Orbit Insertion burn on September 23, 1999. Throughout spring and summer of 1999, concerns existed at the working level regarding discrepancies observed between navigation solutions. Residuals between the expected and observed Doppler signature of the more frequent AMD events was noted but only informally reported. As MCO approached Mars, three orbit determination schemes were employed. Doppler and range solutions were compared to those computed using only Doppler or range data. The Doppler-only solutions consistently indicated a flight path insertion closer to the planet. These discrepancies were not resolved.

On September 8, 1999, the final planned interplanetary Trajectory Correction Maneuver-4 (TCM-4) was computed. This maneuver was expected to adjust the trajectory such that soon after the Mars orbital insertion (MOI) burn, the first periapse altitude (point of closest approach to the planet) would be at a distance of 226km. See figure 4. This would have also resulted in the second periapse altitude becoming 210km, which was desired for the subsequent MCO aerobraking phase. TCM-4 was executed as planned on September 15, 1999.

Schematic MCO Encounter Diagram
